# POOL CONDITION REPORT

**InspectorNick.com**  
home inspection services

7/11/2019

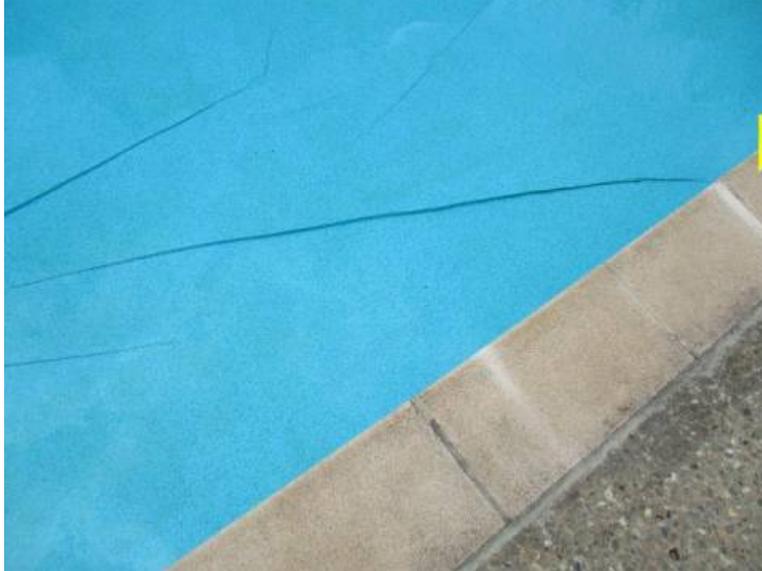
The pool has a Vinyl liner. This liner is relatively new, with little fading / Inquire with the seller as to how old the current liner has been in the pool / Life span of a new liner is 8 to 10 years

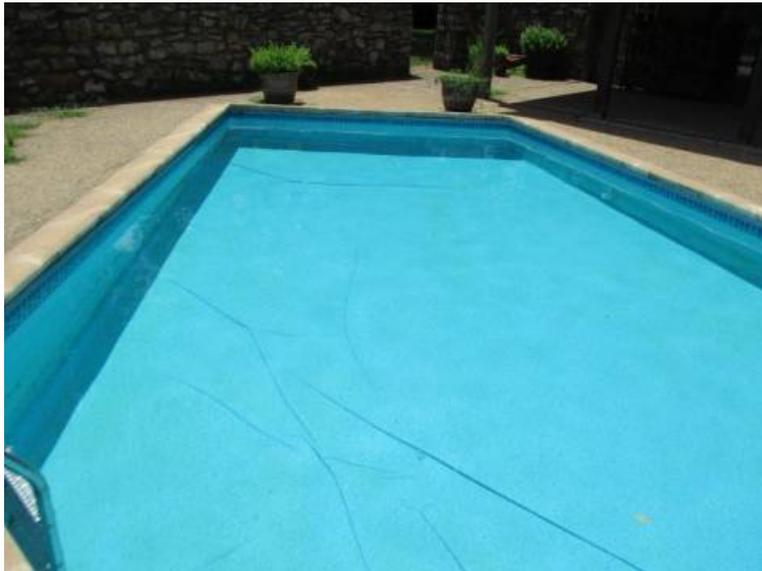
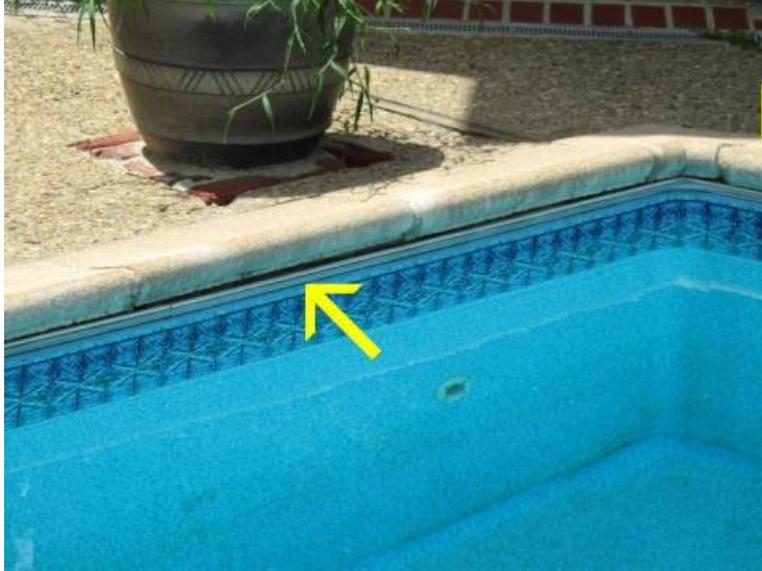
Fair overall condition / The liner is stained heavily from leaves & other debris that was sitting in the pool too long / The liner also shows signs that it has floated (ground water has gotten under the liner & displaced the liner from its settings). It has several wrinkles in the pool that are going to be difficult (or impossible) to remove. I truly feel we could remove a number, if not all, of the wrinkles but the work would need to be done during a dry weather period & soon (cost \$500). This is a serious problem to have & the seller needs to be asked if the reasons has been rectified so as not to happen again. / Robby (the listing agent) said the floating happened because the water was taken so low in the Spring to remove the debris. The process he described "Kelly Company" taking to clean the pool, of the above debris, did not make sense to me. The fact remains that water has & will continue to find it's way to the pool if steps are not taken to remove or alter the ground water / A new liner will run approx. \$3,500 to \$3,800 installed / Behind the liner, the pool has concrete walls. The liner track is coming off the pool walls & is starting to pull into the pool. Estimated cost to repair (when setting a new liner, is \$1,000 or more.

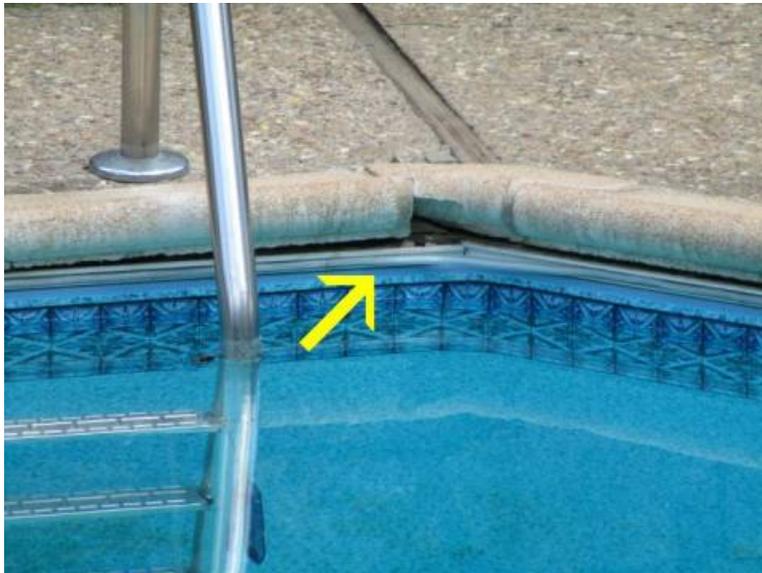
Fair overall / The round bull nose coping has cracking around the pool & various grout seams are flaking away. Very consistent with a pool of this age None of the stones are loose that I could find but they are in need of attention to keep water from getting down the cracks.

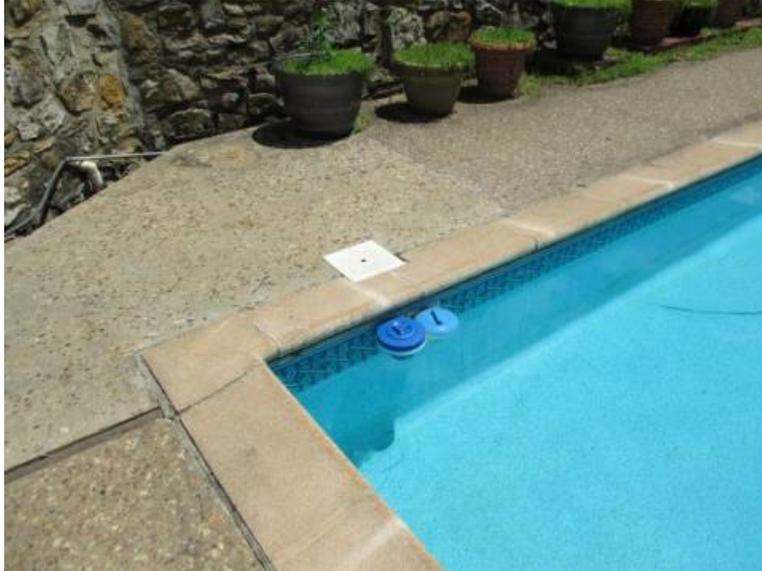
Hayward brand / Square face, Good condition - No cracks were seen in the vessel & it has an operable weir door. The Door kept sticking because the water level was high in the pool. It needs to be sanded down slightly.

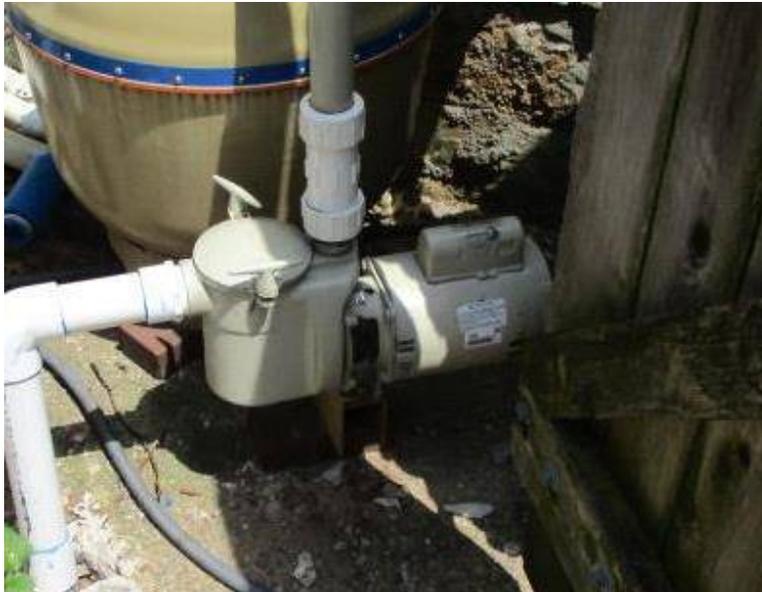
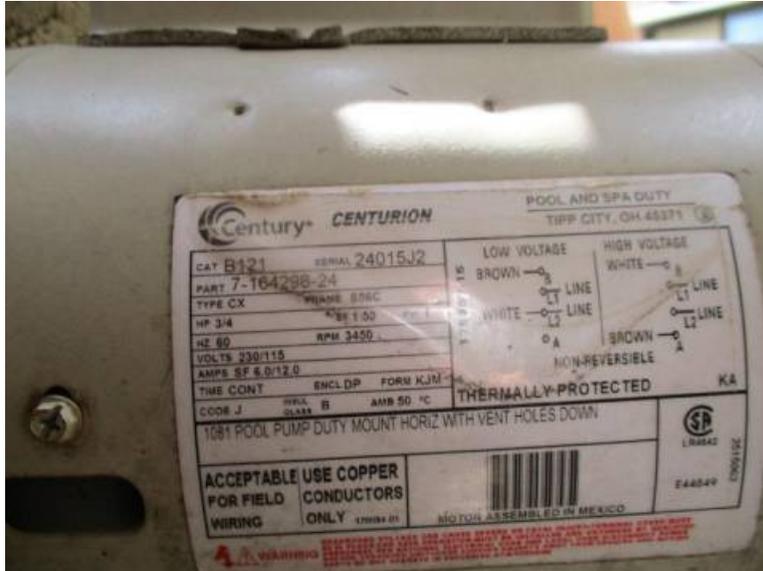
Sta-Rite brand pump - 0.75 HP with a 1.12 Total HP motor / Fair- motor & pump is aged / The pump has an open faced brass impeller, a small basket & is not as efficient as the newer models but is built much better than it's younger counterparts.

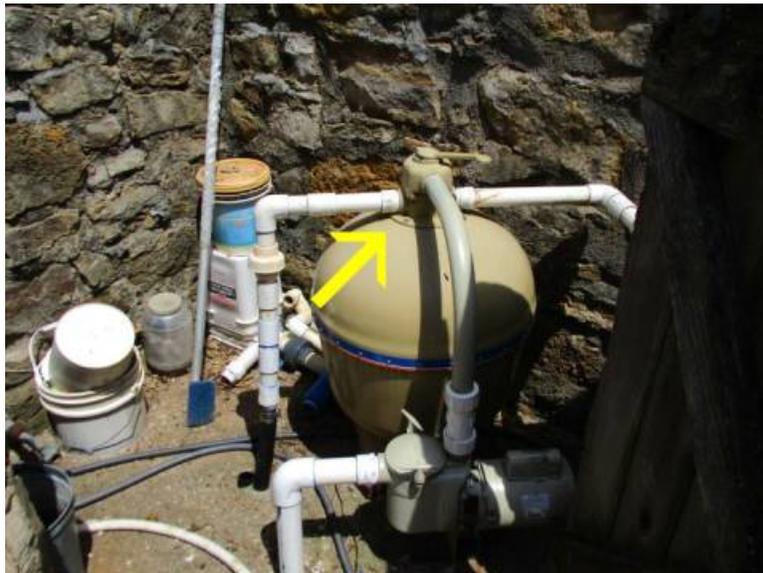
Top Mount valve, / 1.5" Valve ports.

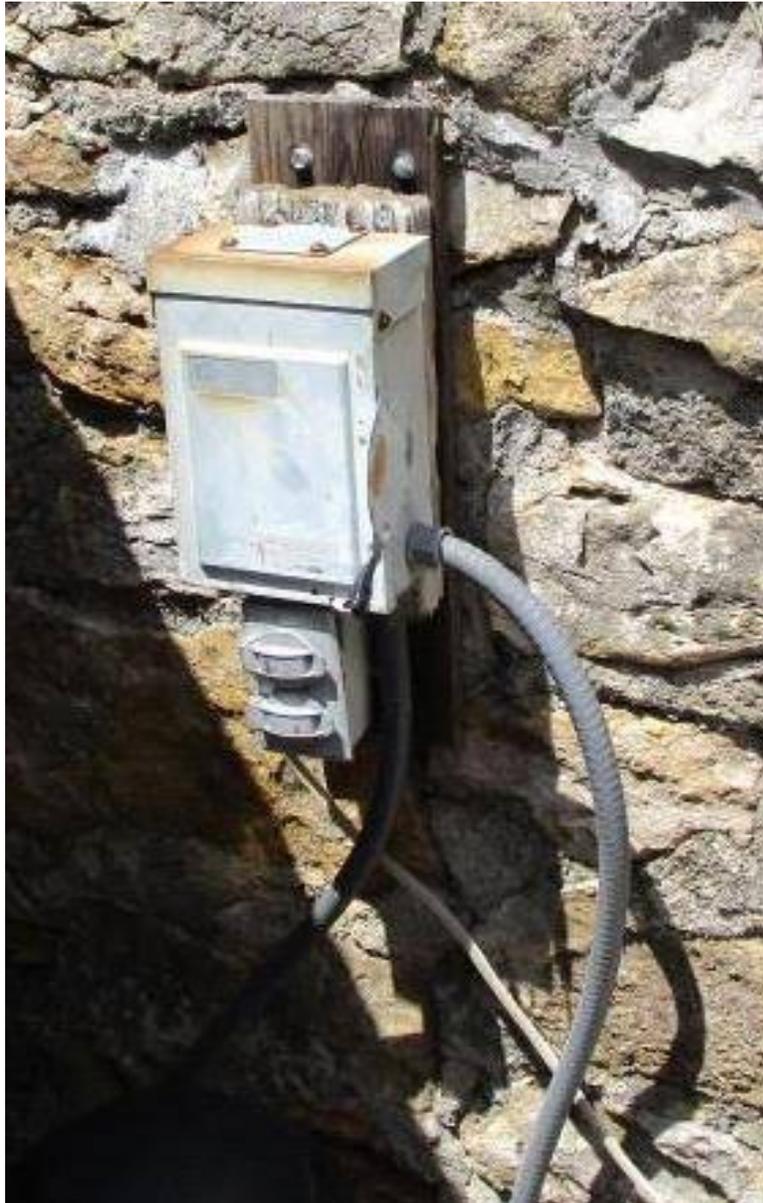
The pump's electrical switch, mounted on the stone wall, is precariously placed & needs to be secured. It fell twice during my inspection.

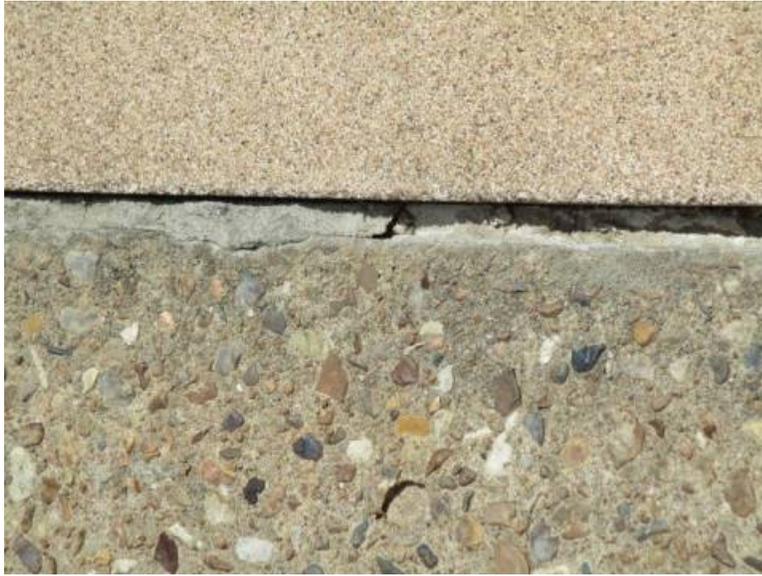
This is a deck that was indicative of the pool builder. It has stone in concrete which makes it hard to walk on in bare feet or kneel down on / Minor settlement cracks are noted at several locations as the deck is older / The Expansion Joint in between the coping & the concrete deck is in need of attention. The joint is starting to separate & is no longer water tight. It will allow water to seep down the joint which could freeze & break up the deck during the cold winter months / The area has a drainage ditch that surrounds it & is even used to dispel the water from the pool system when need be. The ditch needs to be cleaned out, patched & resealed as several holes will allow water to

get into the ground around the pool.
