HOME CONDITION REPORT

InspectorNick.com
home inspection services

February 1, 2019

1404 SW Market Street, #1101
Lees Summit, MO 64081
(816) 347-8955

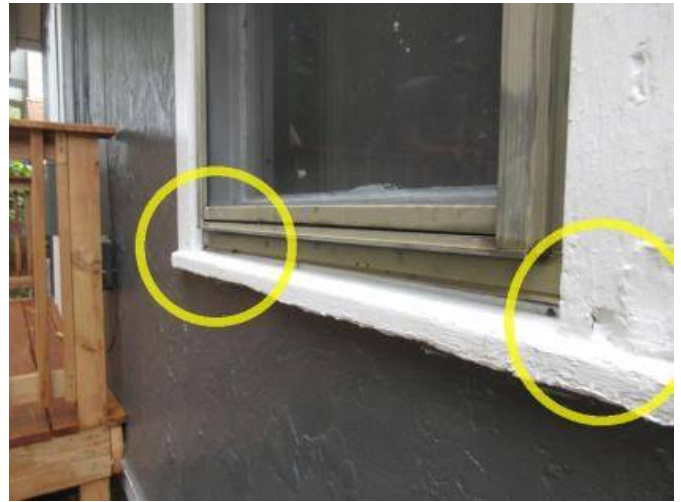
Wood decay and moisture damage was observed at window sills/brick molding on the rear main level bedroom.

Replacement of affected wood decayed area(s) recommended.

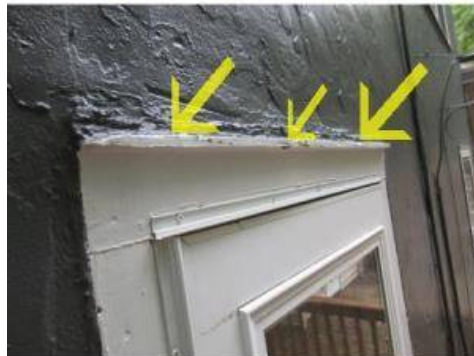
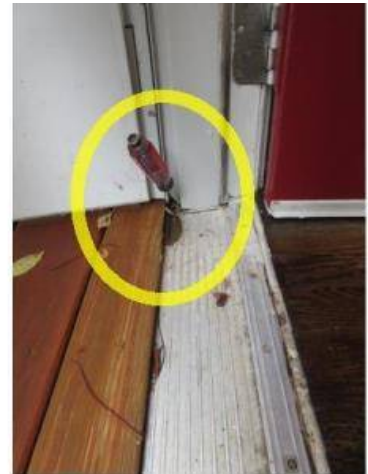
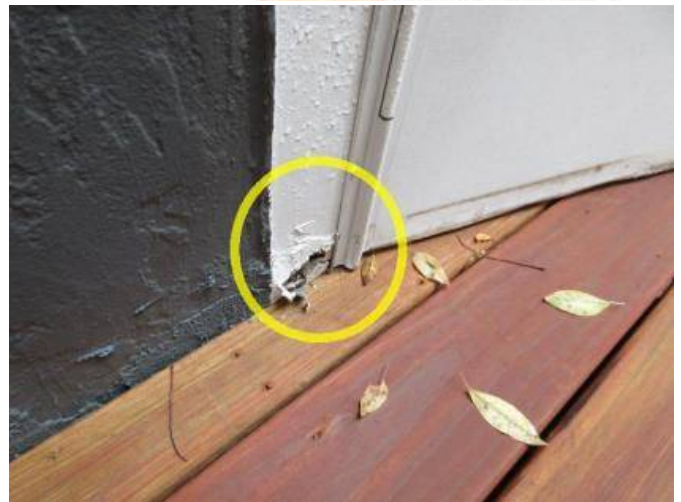
Wood decay and moisture damage was observed on the exterior trim at the head trim above and base at rear door deck. Replacement of affected wood decayed area(s) recommended.

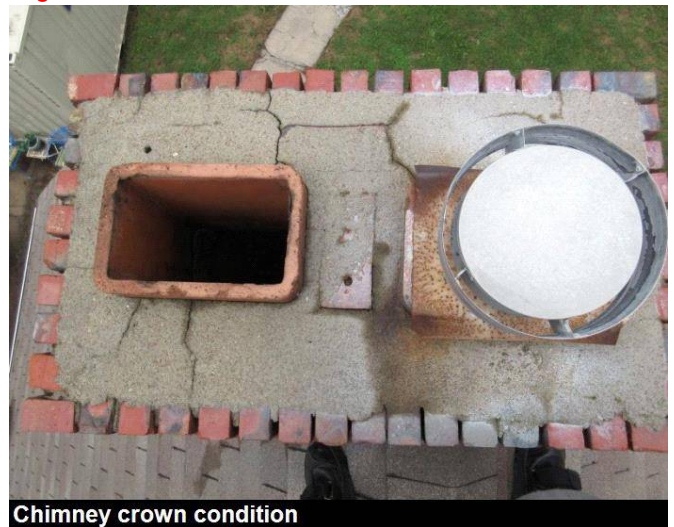
Cracks and significant weathering was observed in the crown of the chimney. The crown is the beveled concrete surface that provides watershed around the flue at the top of the chimney. These cracks occur due to the heat expansion of flue tiles in contact with chimney crown. Correct installation of the chimney crown would have a gap/bond break between chimney crown and flue tiles that is filled with fire rated sealant and allows the expansion of the flue tiles to occur without stress on the chimney crown. Due to the current condition of the crown or wash, replacement by a qualified chimney mason is recommended to prevent further erosion and water intrusion. Provisions for the gap/bond break, will prevent future cracking issues.

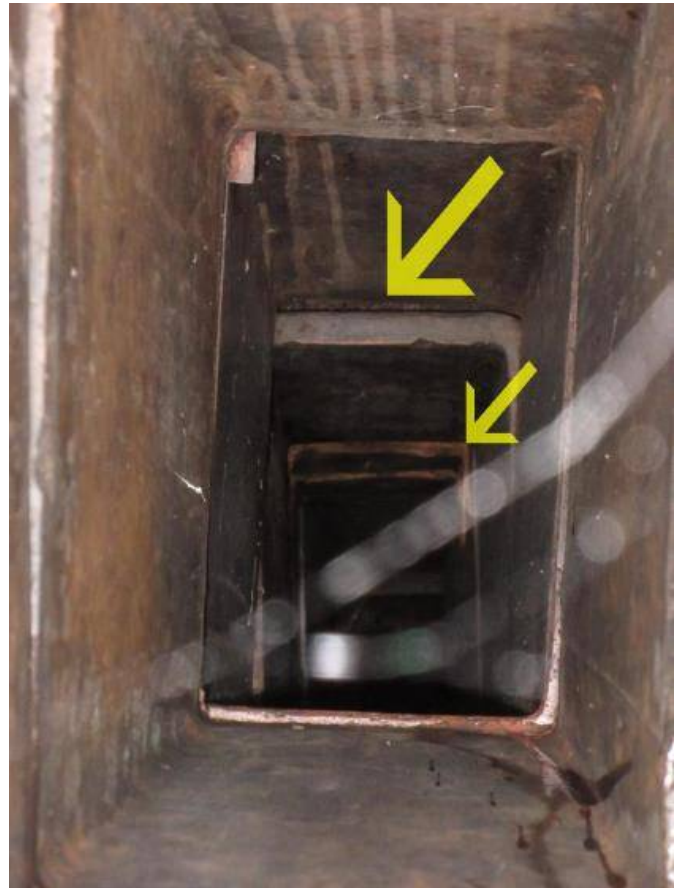
The flue tile system is not correct and offsets at flue tile joints were viewed. This condition allows harmful gases with water vapor to condensate on interior brick of chimney. It is recommended that the chimney and the liner condition be evaluated by a qualified chimney sweep prior to closing to determine needed repairs prior use.

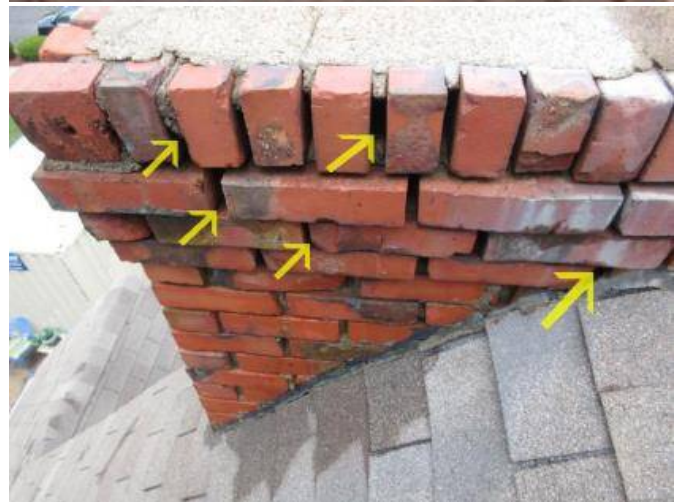
Deteriorated brick mortar was evident at the exterior of the chimney. Repointing is recommended to ensure future reliability of the chimney.

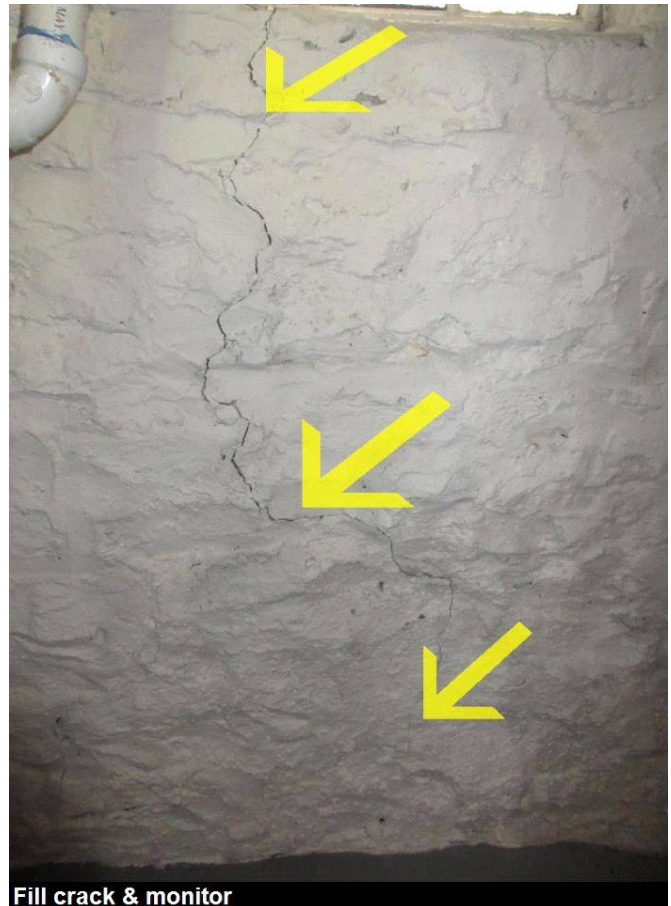
The basement foundation walls were stone and mortar. The foundation wall has moved at NW corner. Indications of settlement or heaving was present by evidence of vertical and/or angular cracks. Full evaluation of these conditions is beyond the scope of this inspection. It is recommended that the condition be periodically monitored. If any worsening of the condition is detected, contact a professional engineer for further evaluation.

Fill crack & monitor

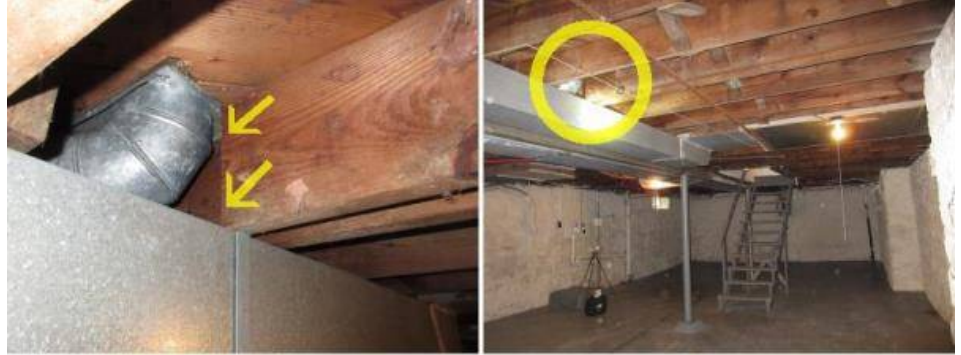
One joist in basement ceiling has a section of it removed or over notched to accommodate the ductwork and the integrity of the floor joist is compromised and sagging. Additional support under the "floating" joist ends or "heading" off the joist ends with an appropriately installed header board fastened to parallel joists on both sides of compromised joist is necessary. Consult qualified carpenter for further evaluation and necessary repairs.

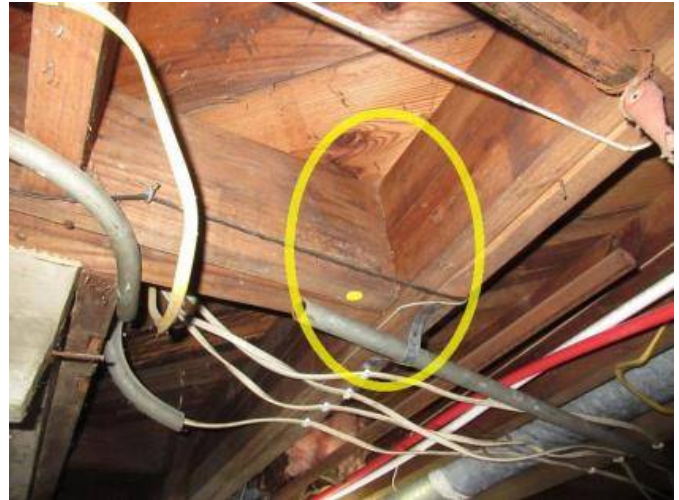
Joists hangers are missing at beam ends around opening for basement stairs. Installation recommended for proper load bearing support. Consult qualified carpenter for evaluation and installation of appropriately sized hangers and fasteners.

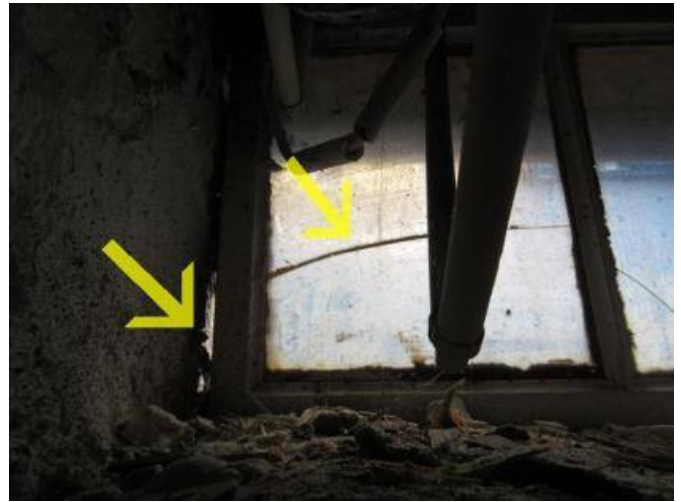
One or more basement windows were cracked/broken, missing or have been improperly installed. Gap to exterior aside window. Repair or Replacement of affected windows recommended.

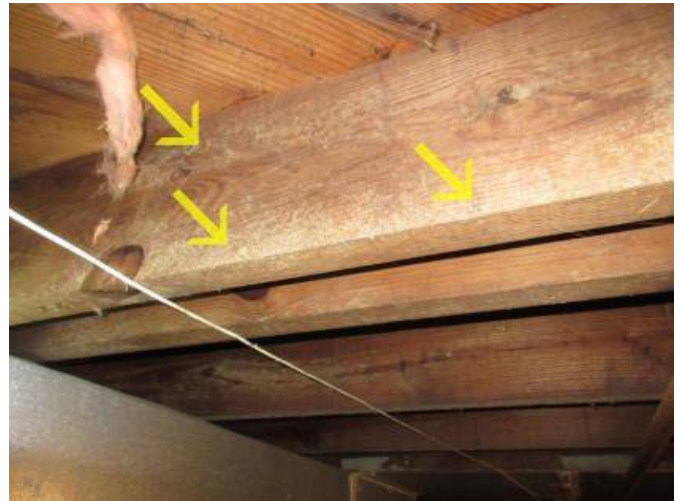
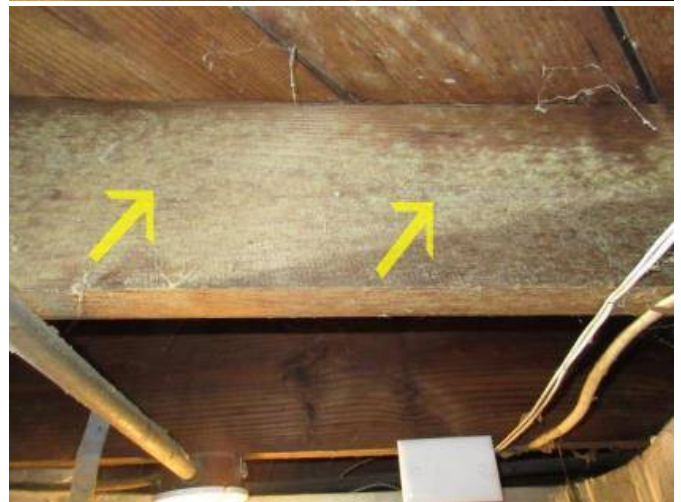
The growth of mold was present at floor joists throughout basement. Mold is often the result of continual or regular moisture on building materials. Some molds may cause illness or allergic reaction. Identification of airborne mold and risk assessment is beyond the scope of this level one cursory visual inspection. It is recommended that the home air quality be tested to determine the extent and type of molds that may be present. Consult with our office to schedule indoor air quality mold sampling for additional fee.

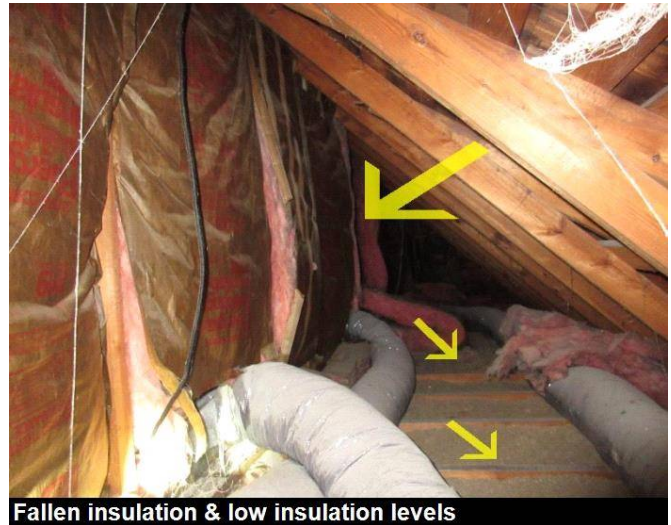
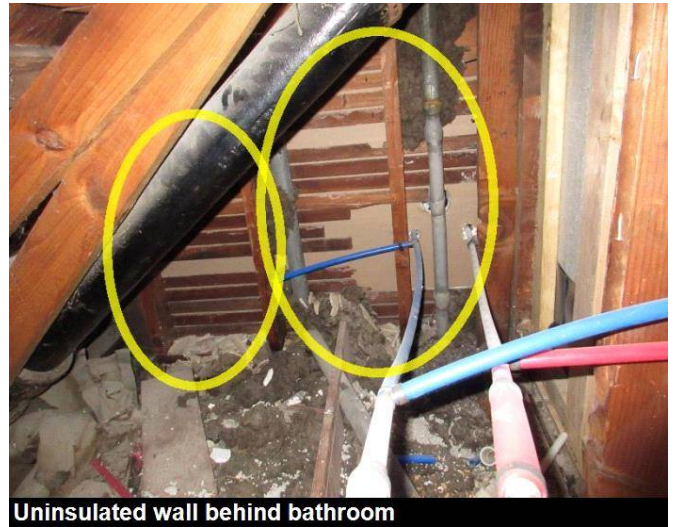
The insulation depth was insignificant resulting in nominal R-value. Insulation was installed between the ceiling joists on the floor in the attic. Installation of additional insulation in the attic area is recommended for energy savings and comfort. The standard level of insulation in this area is R-38. Insulation was installed on the attic walls where 2nd level interior walls adjacent attic space, unfortunately one or more insulation batt were missing or have fallen. Re- Installation recommended to prevent unwanted heat loss in these areas.

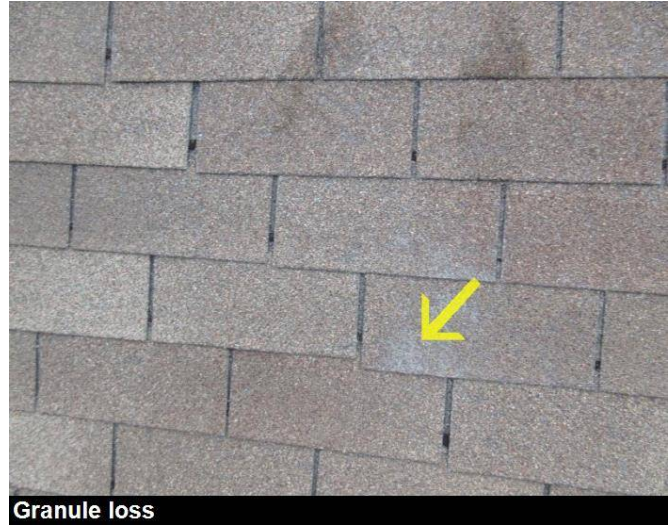
Hail damage was noted in the roof covering materials. This was confirmed by dents in the exposed metal vent covers and/or impact marks within roof covering. Considerable hail damage was noted. Replacement of affected areas recommended. It is recommended that the homeowner contact their insurance company to see if their coverage will replace the affected materials.

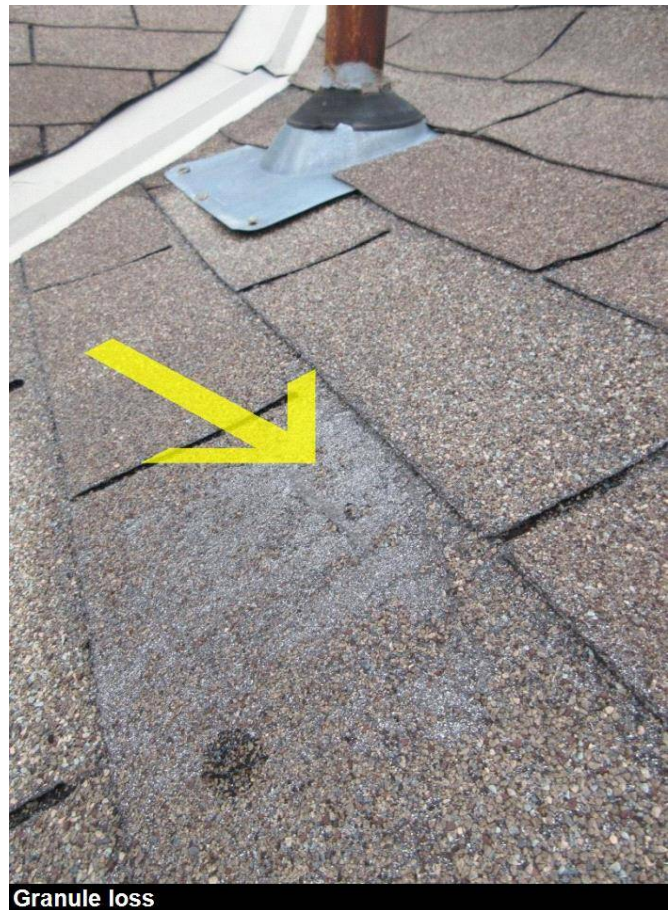
There is excessive granular loss. This is a warning that the shingles are not protected from the ultraviolet rays that cause deterioration to the asphalt mat.

Granule loss

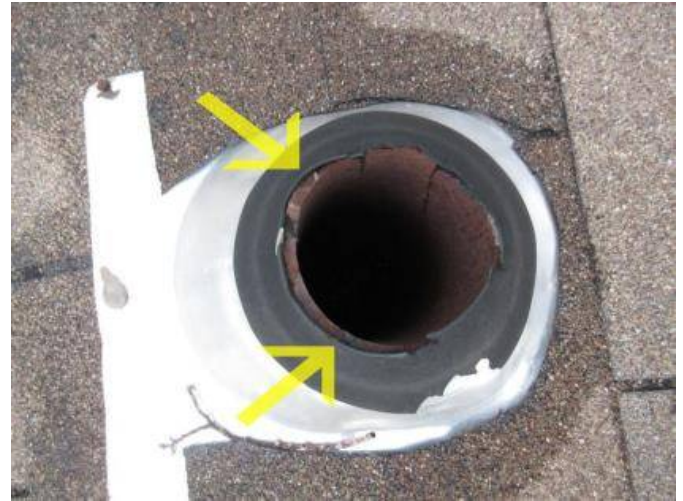
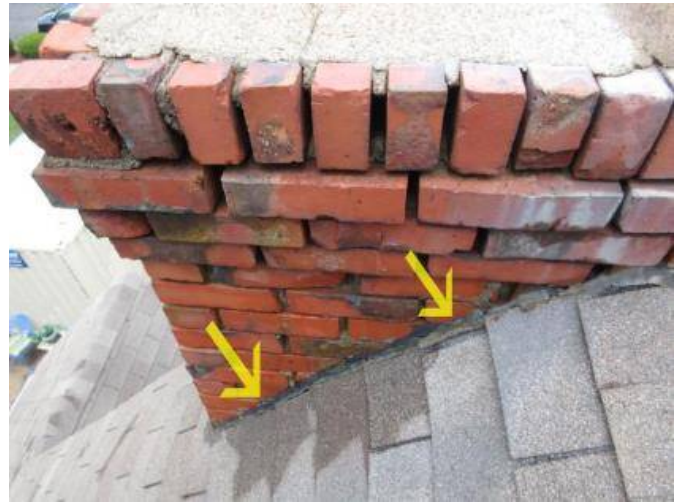
Metal and rubber roof flashings were present. Most of the roof flashings appear to be serviceable. However, some areas require attention as follows: **The rubber boot flashing that provides watershed from around plumbing vent stack(s) through roof was cracked. Repair/Replacement is recommended.**

Chimney flashing has separated from chimney. This condition provides potential leakage into attic space or interior of structure. Repair is recommended. Consult a qualified roofing contractor for further evaluation and repair or improvement as necessary.

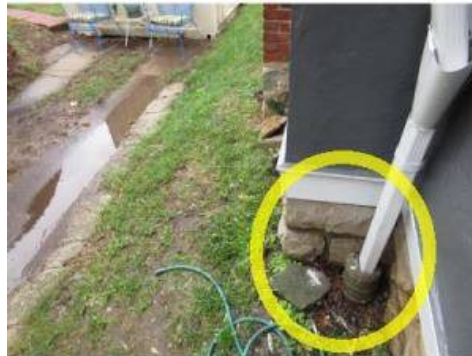
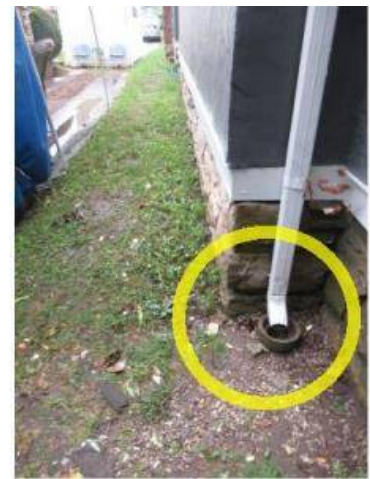
A metal gutter system was present. Some old subsurface downspout leader pipes were observed and most likely drain to sewer. Due to the underground installation, operation and performance of the subsurface drainage system can not be evaluated within the scope of this inspection, and further evaluations with drain camera recommended. Sometimes these old underground systems leak, draining water next to foundation.

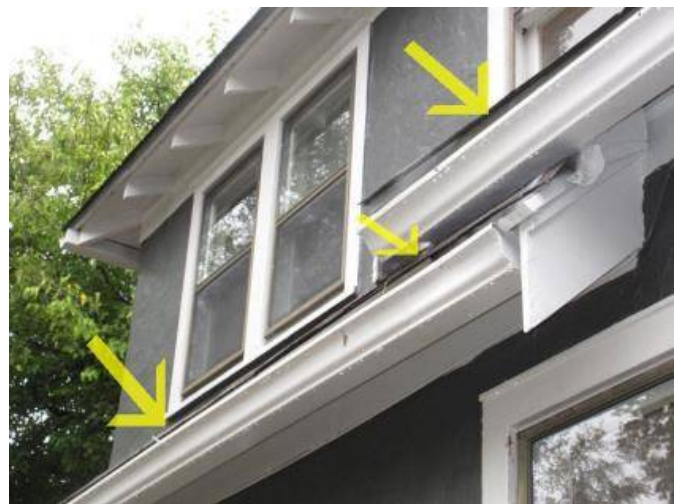
Due to excessive number of roof covering layers, the roof's edge extends well beyond the back of the gutter allowing roof water to overshoot gutter system. Recommend removal of gutter system in this location and installation of a shim board attached to original fascia board behind gutter to ensure roof's edge drains into the gutter properly.

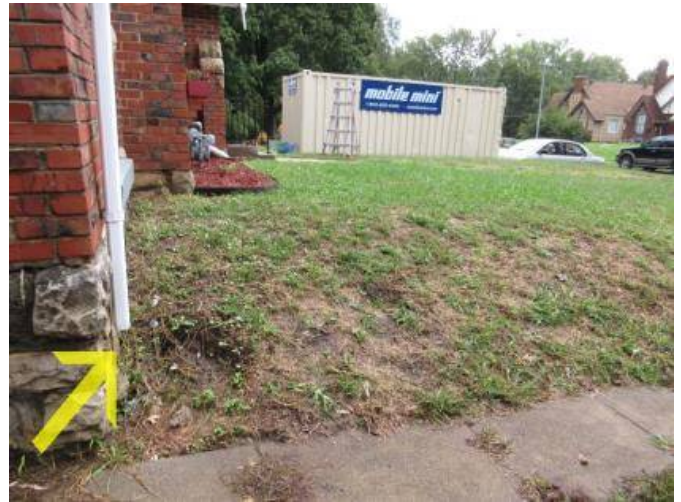
The installation of gutter downspout extension leaders and splash blocks is recommended to direct water away from the foundation and avoid soil erosion and saturation at the foundation. Use of subsurface downspout pipes recommended when increased distance away from foundation is needed in excess of five feet.

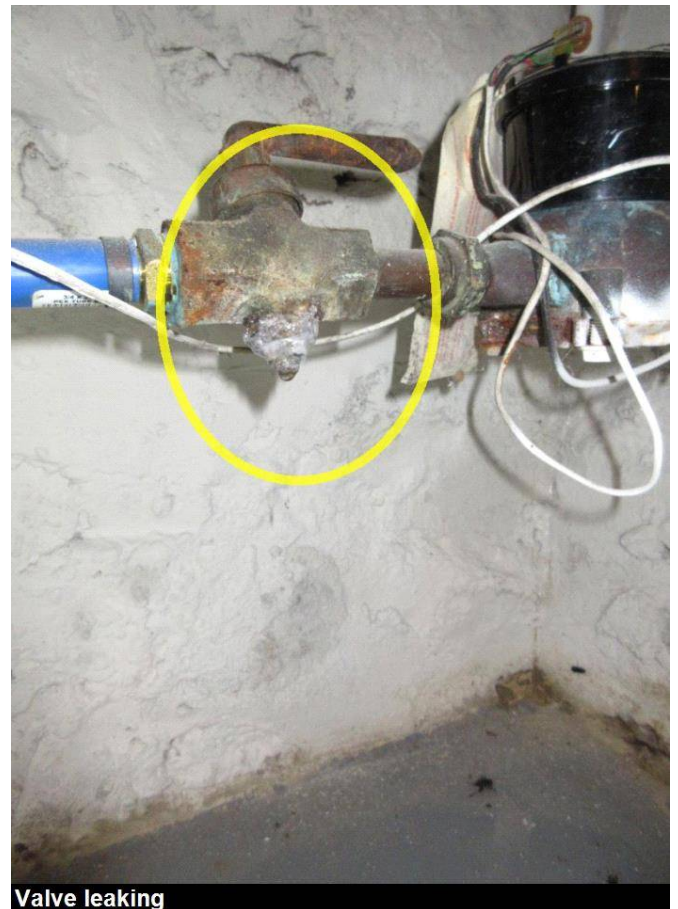
A leak was observed at the main water valve. Repair or improvement is recommended. Contact a qualified plumber for further evaluation and repair or improvement as necessary.

Valve leaking

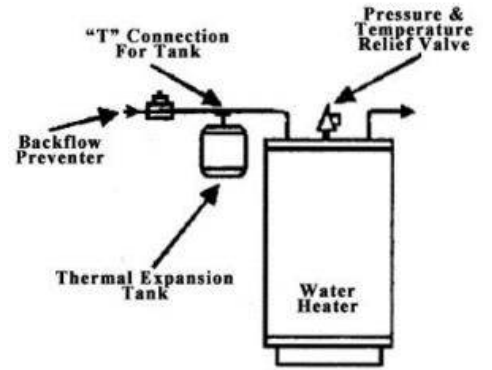
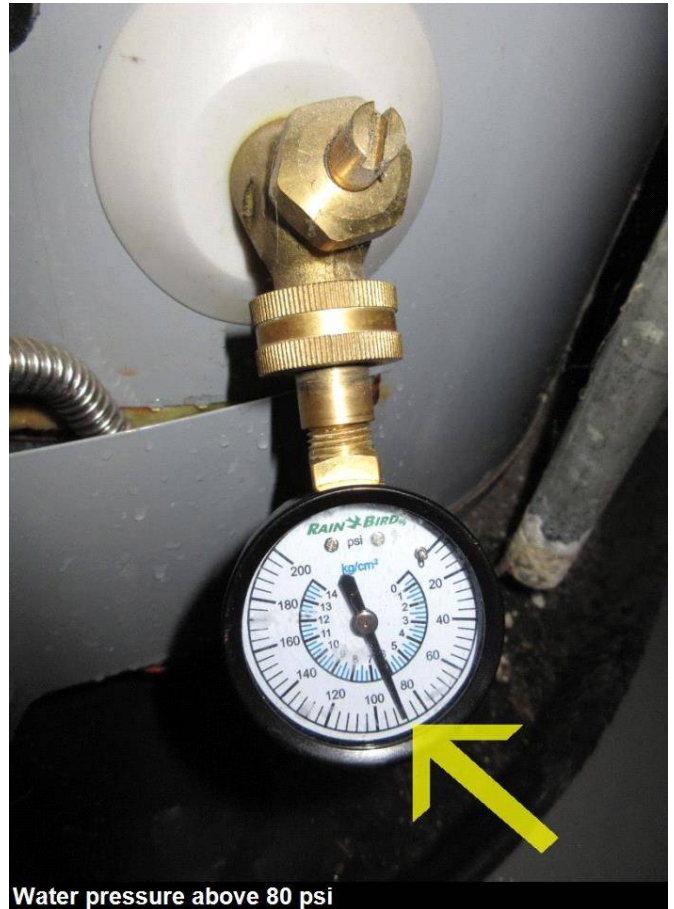
The water pressure is over 90 psi. Water pressure this high can cause damage to fill valves in toilets, dishwasher, and clothes washer. A water pressure regulator valve should be installed to regulate the pressure to an acceptable 40 to 80 psi range. With the presence of the hot water tank creating "thermal expansion" in a closed water system, rapid and dangerous pressure increases in the water heater tank and system piping due to heating of water. Although the age of structure may predate requirement, installation of a thermal expansion tank in the line between the main water shut off/check valve and water heater tank is recommended to prevent possible leakage/failure of the Temperature and Pressure relief valve on the water heater tank and overall stress to the hot/cold water supply plumbing system. Consult a qualified plumber for further evaluations and installations.

Water pressure above 80 psi

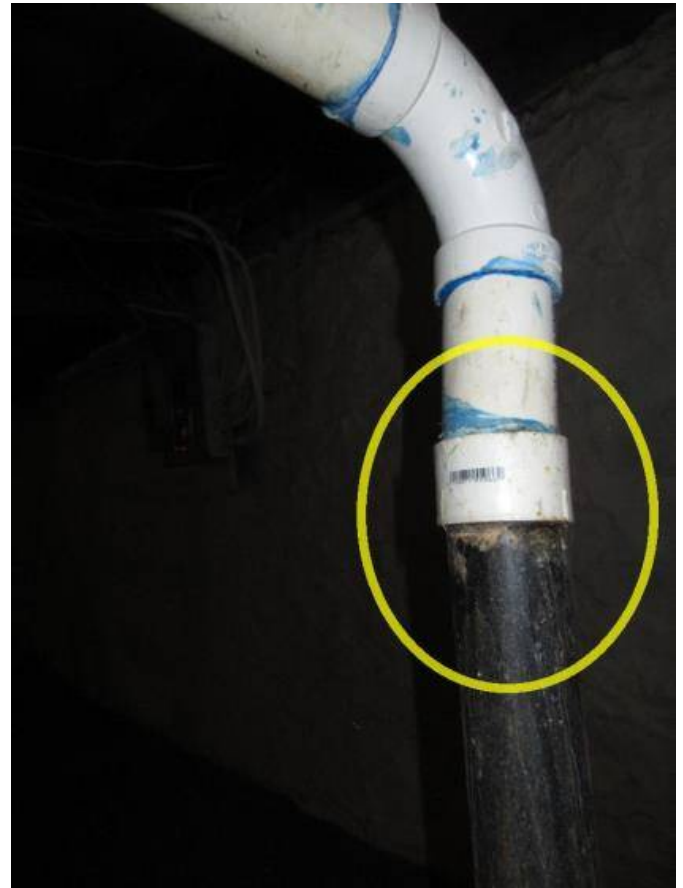
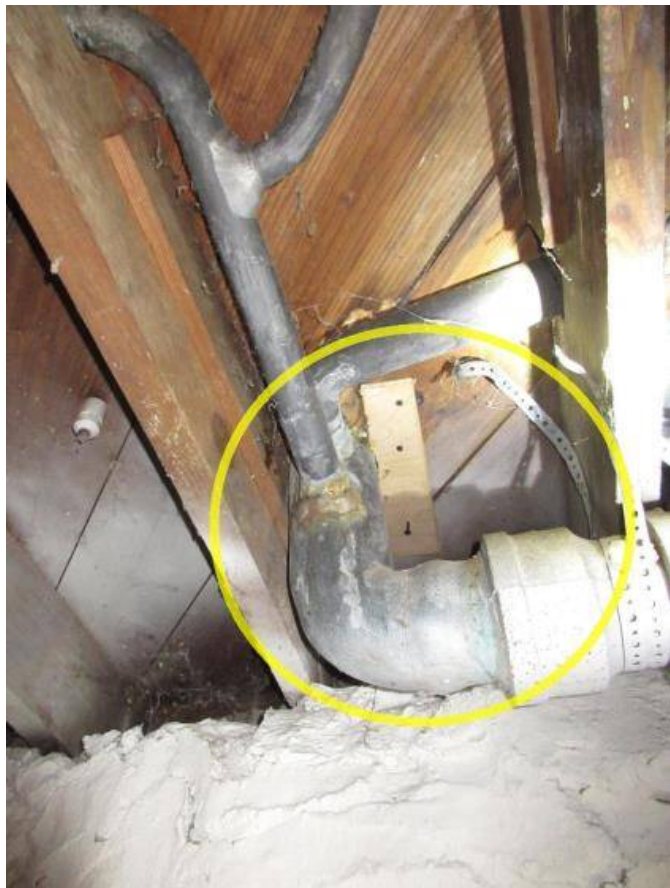
The waste water pipes were PVC (Polyvinyl chloride) plastic, ABS (Acrylonitrile Butadiene Styrene) plastic, lead and galvanized. Most of the waste water pipes appear to be serviceable. However, some attention is needed as follows: **Water leakage was observed at standpipe in basement under kitchen and lead drains in basement ceiling under bathroom. Repair or improvement is recommended as good maintenance. Contact a qualified plumber for further evaluation and repair or improvement as necessary.**

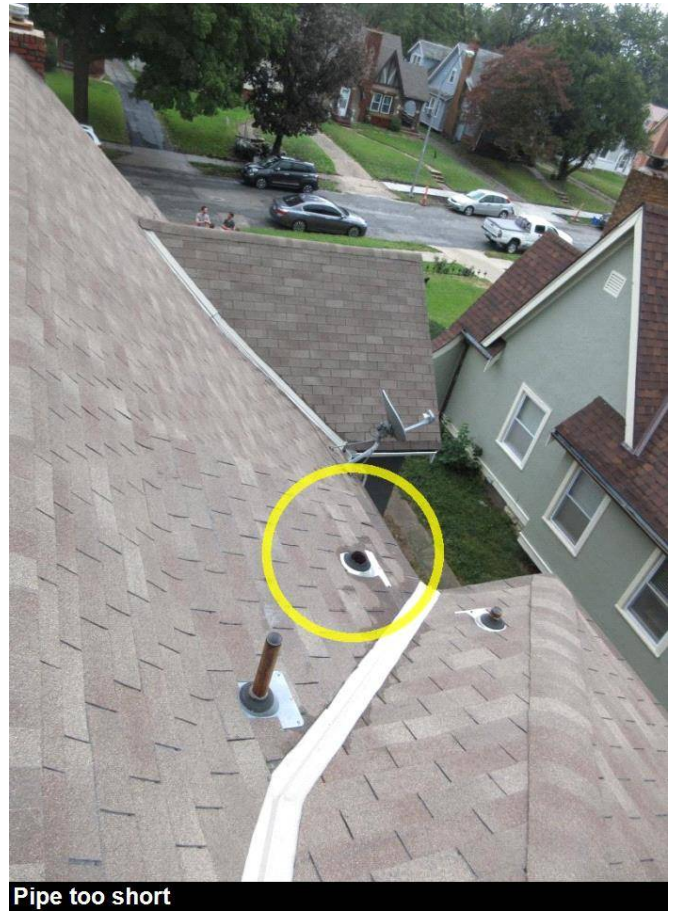
Main waste stack vent pipe through roof is too short resulting in inability for flashing seal. Contact a qualified plumber for further evaluation and repair or improvement as necessary.

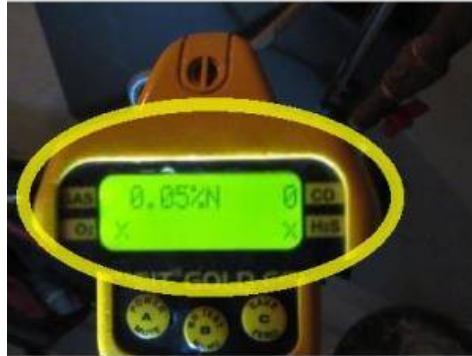
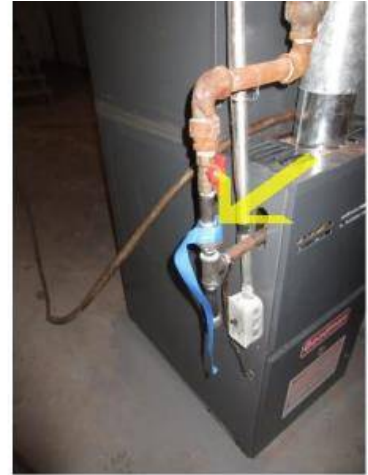
A gas leak was present at the interior, in basement near furnace, identified with blue tape. See attached pictures for locations. Repair or improvement is recommended for safety purposes. Contact a the gas utility company for further evaluation and contact plumber for all necessary repairs or improvements as necessary. It is recommended that either the gas company or our team return after repairs are completed to verify no gas leaks remains, as our experience proves many times, gas leaks are overlooked and/or not repaired fully.

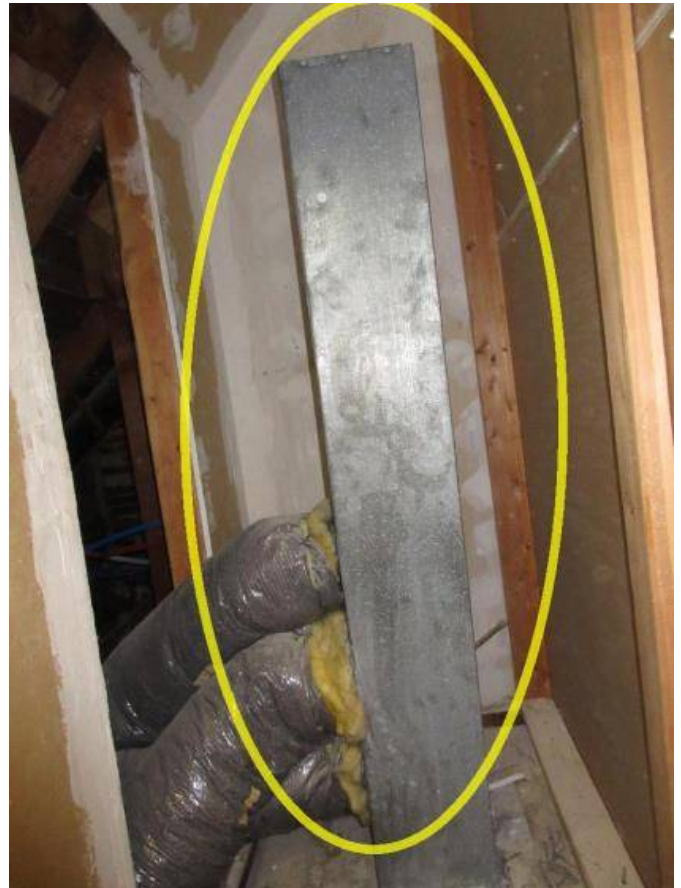
Insulation wrap is not continuous to duct transition in attic space allowing possible Heat/Cool loss and potential of condensation during cooling season. Consult a qualified heating, ventilation and air conditioning (HVAC) contractor for further evaluation and repair or improvement as necessary.

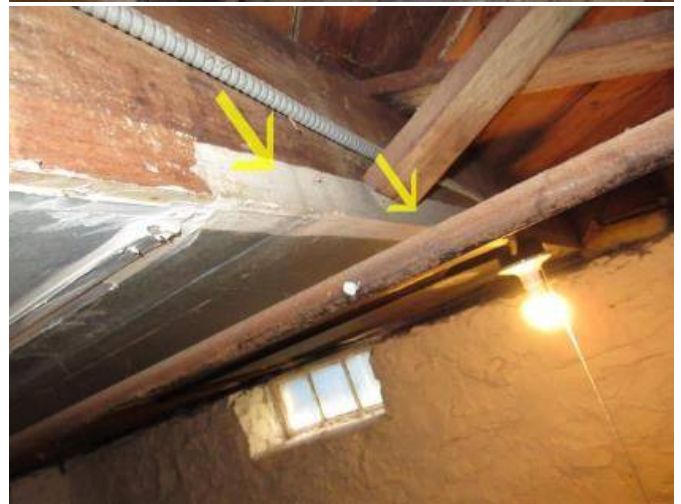
Insulation on the supply ducts in basement ceiling was suspected of containing asbestos. Testing for asbestos and evaluating the potential risk is beyond the scope of this inspection. Consult an asbestos testing specialist for further evaluation, as necessary.

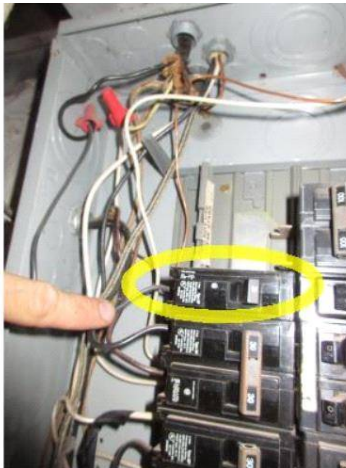
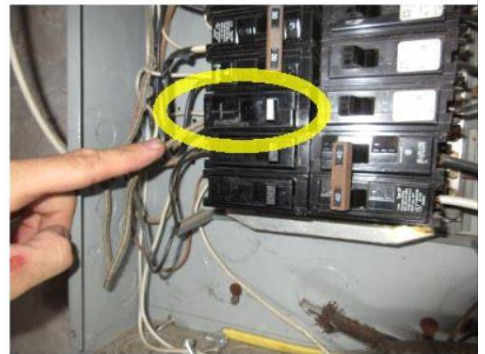
Circuit breakers were present in the main panel box. Oversized circuit breakers have been installed in the panel box. Such conditions may result in overloading of the wiring and potentially fire may occur. Installation of properly sized and rated circuit breakers is recommended. Consult an electrician for further evaluation and repair or improvement, as necessary.

Oversized breakers

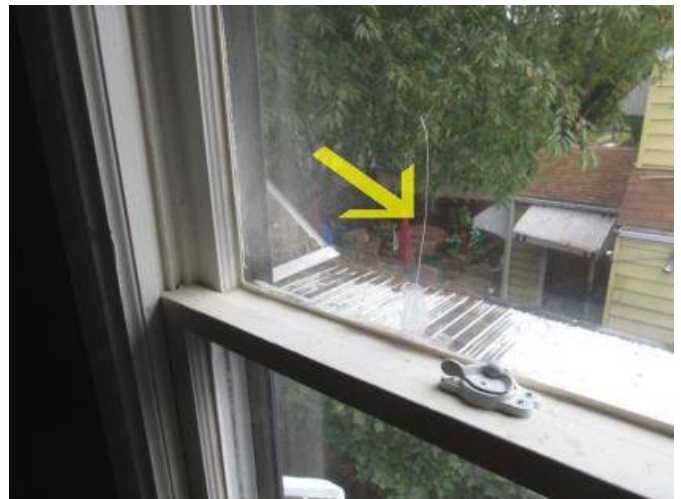
All windows throughout home were hard to operate or painted closed. Service windows and recheck and make all necessary repairs to restore proper operation to windows for convenience and reliability of safety for egress.

A few windows were cracked. Replacement of the window pane(s) is recommended as good maintenance.

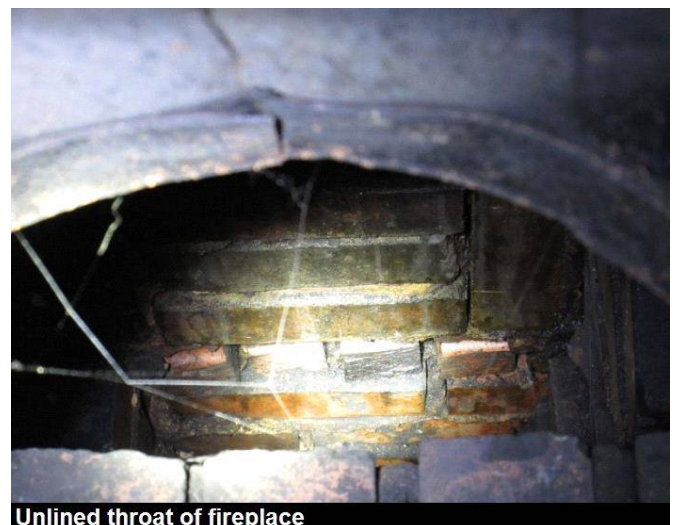
The chimney does not have a proper liner installed. This is common in older homes where the flue consist of a brick chimney without a terra cotta liner. In some cases older terra cotta liners have failed and require replacement as well. The failure of a chimney liner can lead to leakage of deadly gases into the living spaces and carbon monoxide poisoning. Have the integrity of the chimney joints verified by a qualified chimney sweep or masonry contractor. Often brick lined chimney require installation of a metal liner or complete renovation to restore safe operation. Repairs should be performed as necessary.

Unlined throat of fireplace
