HOME CONDITION REPORT

InspectorNick.com
home inspection services

February 1, 2019

1404 SW Market Street, #1101
Lees Summit, MO 64081
(816) 347-8955

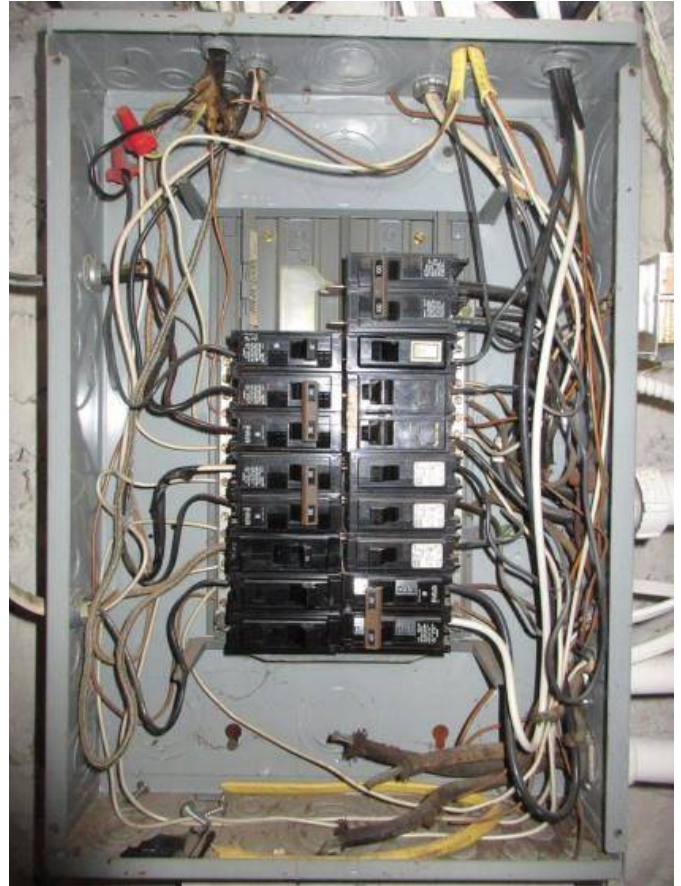
7.2 MAIN PANEL: LOCATION:

Circuit breakers were present in the main panel box. Oversized circuit breakers have been installed in the panel box. Such conditions may result in overloading of the wiring and potentially fire may occur. Installation of properly sized and rated circuit breakers is recommended. Consult an electrician for further evaluation and repair or improvement, as necessary.
